August 20, 1987

Re(s): Progress Report #1, submitted May 18, 1987

This progress report describes the final corrective actions taken to the deficiencies and improvements suggested for completion by the N.W. Regional DOE Response Team. Additionally, this report contains a description and diagram of the Surface Water Management Plan, (storm drainage system) also requested by the Response Team. This Progress Report, like reports number one and two, will be keyed to each action number referenced in the initial report dated May 18, 1987.

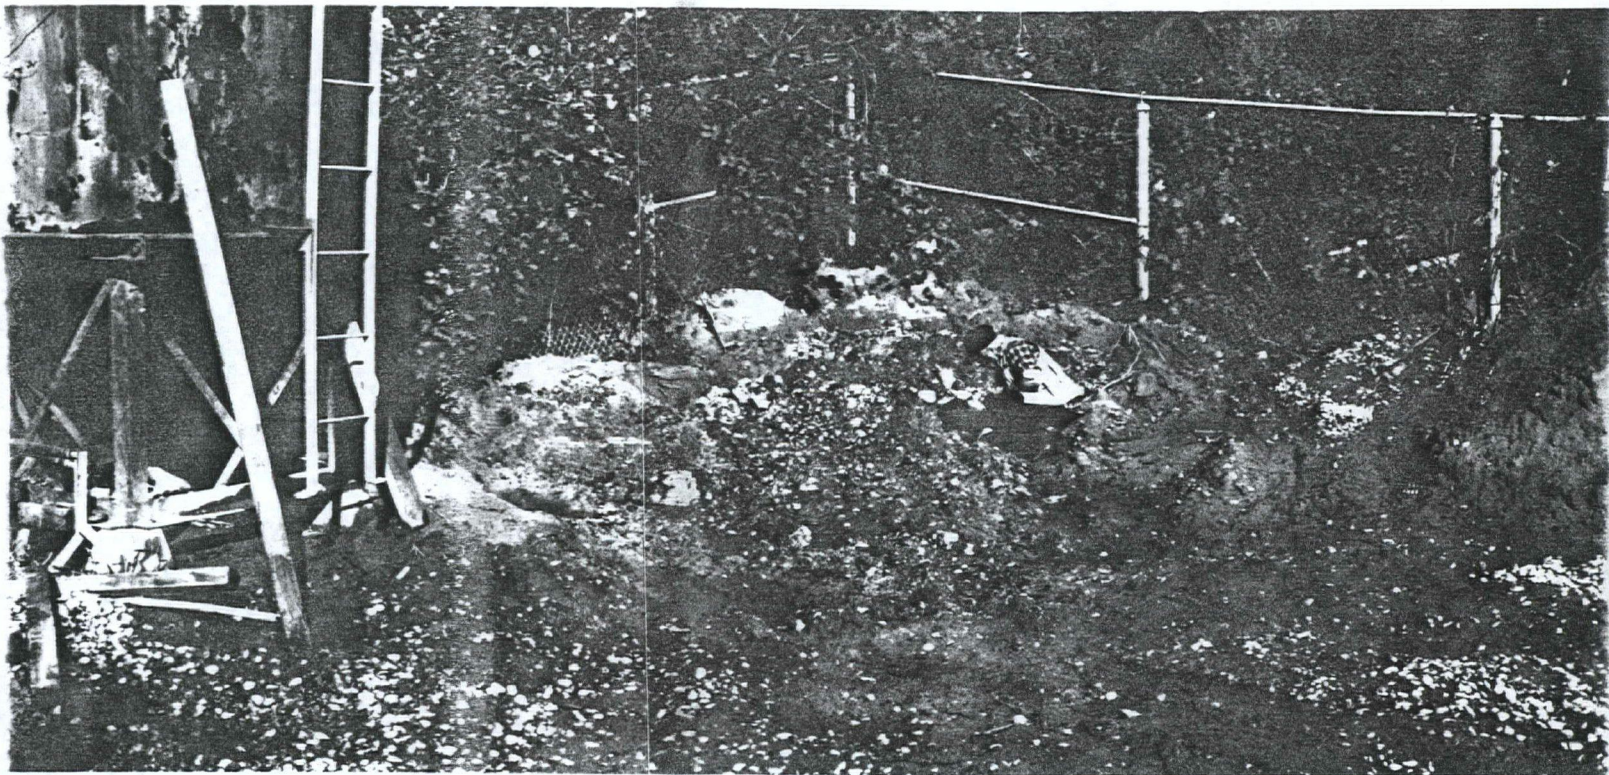
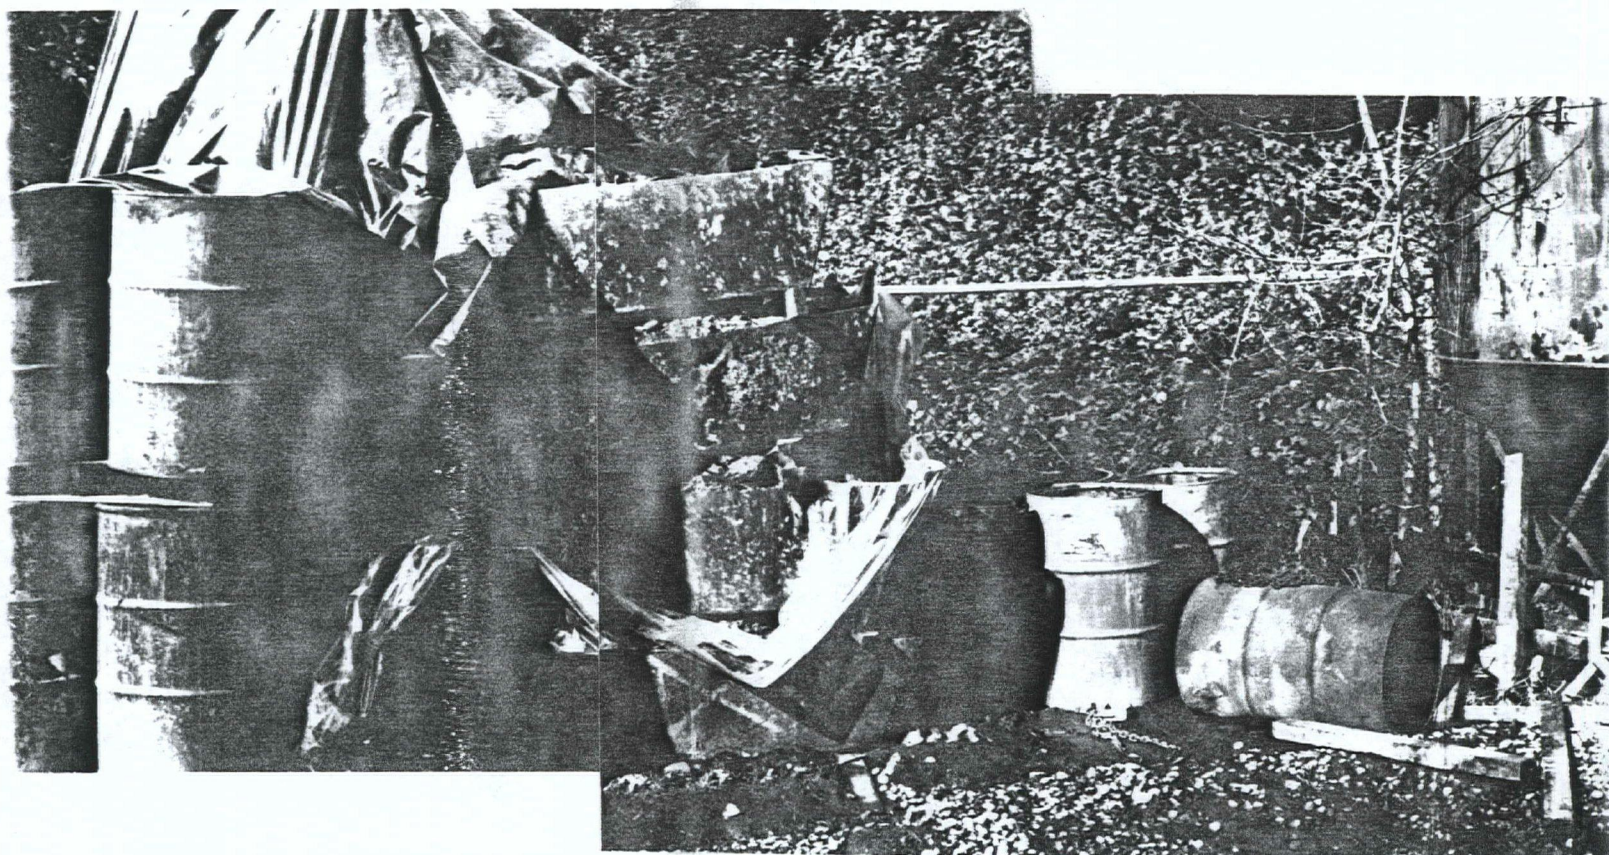
BEFORE PHOTOS

Status: Waste was segregated into three (3) categories and subjected to both the E.P. toxicity tests (including copper, nickel and zinc) and the 96 hour State Fish Bioassay. All three categories of waste have been categorized as dangerous waste (DW) and will be disposed of as directed by the Seattle-King County Department of Public Health and the DOE. The company is now actively working to reduce the copper, nickel and zinc levels formed in this slag by-product so as to reduce the amount of DW generated. In the interim, the other action associated with Action Item #1; i.e., Cleanup of Outside Storage Area, has been completed as evidenced in Photo Series #1. (Area where barreled by-products were stored. Western side of Ace Galvanizing.)

Area where barreled by-products were stored. Western-side of Ace Galvanizing.

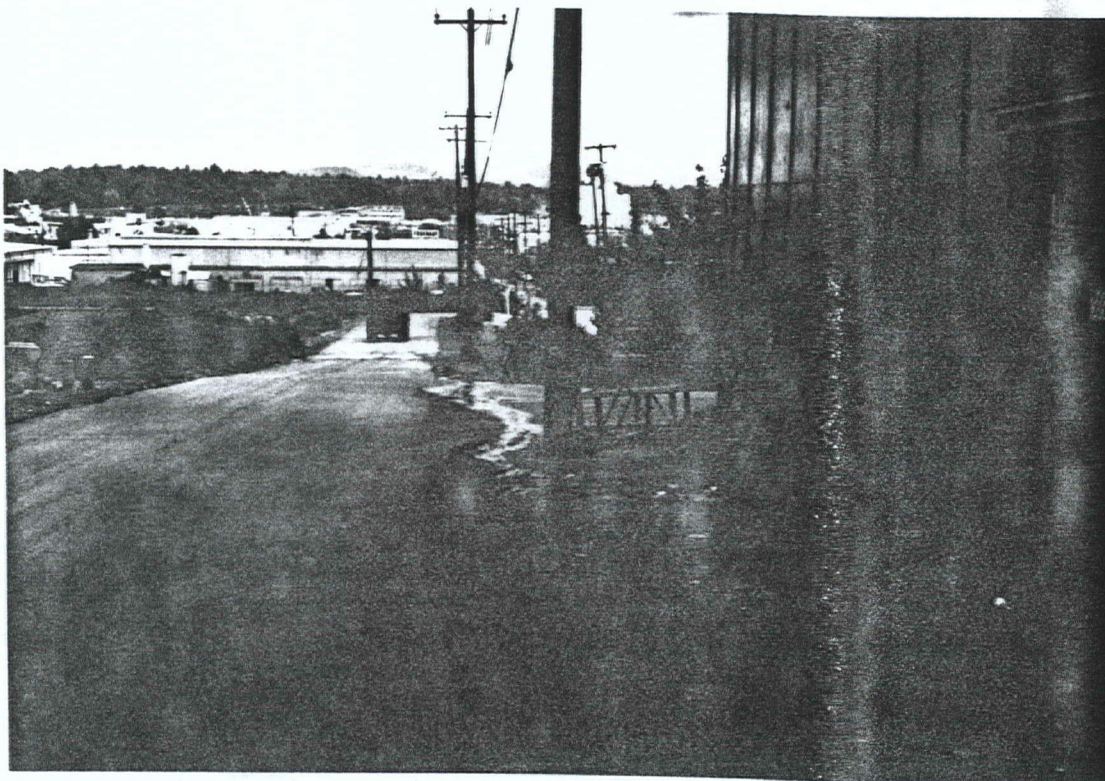
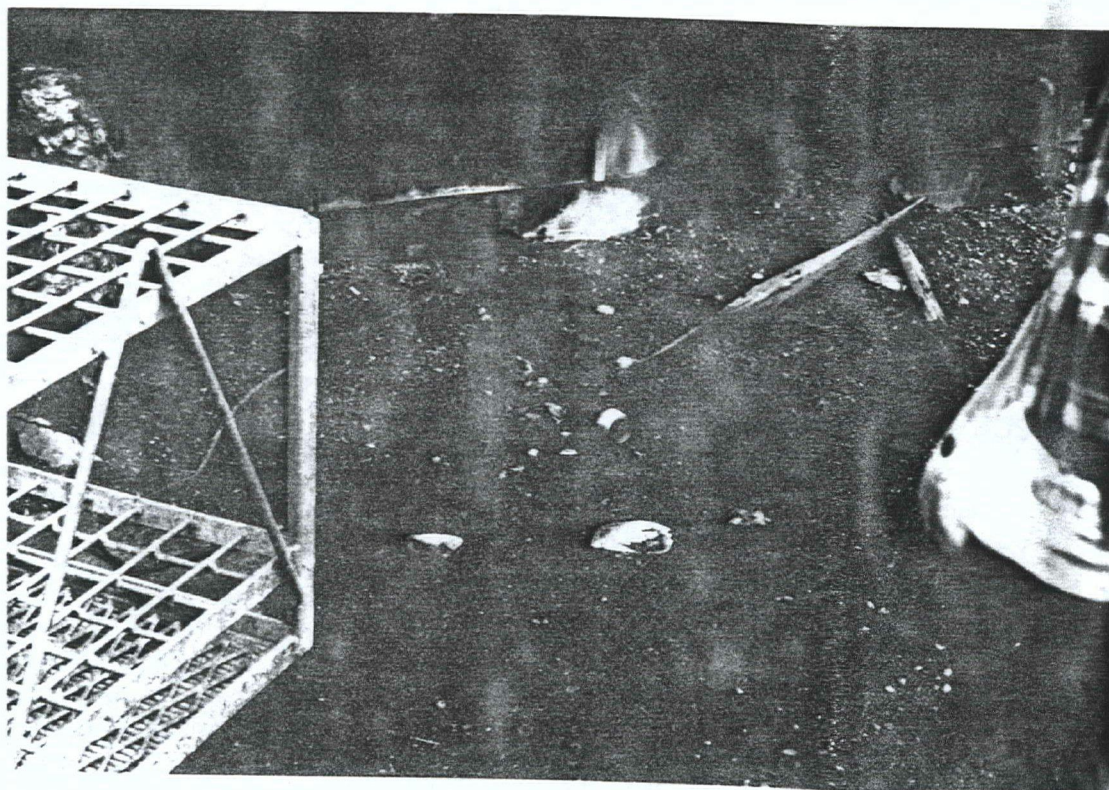
BEFORE PHOTOS

2.      COOLING WATER DRAINAGE FROM BOILER-BLOW DOWN (UNAUTHORIZED DISCHARGE TO STORM DRAINAGE)

Area on north-side of galvanizing building where water from the boiler flow-down operation was running outside of the building.

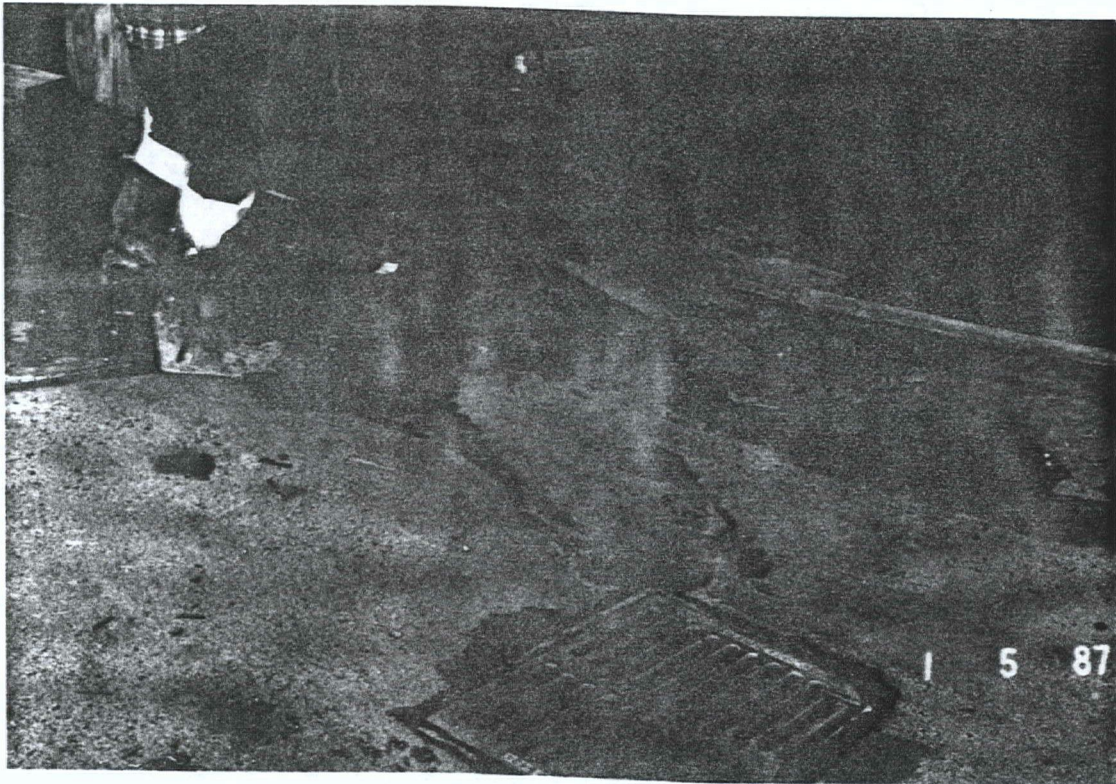
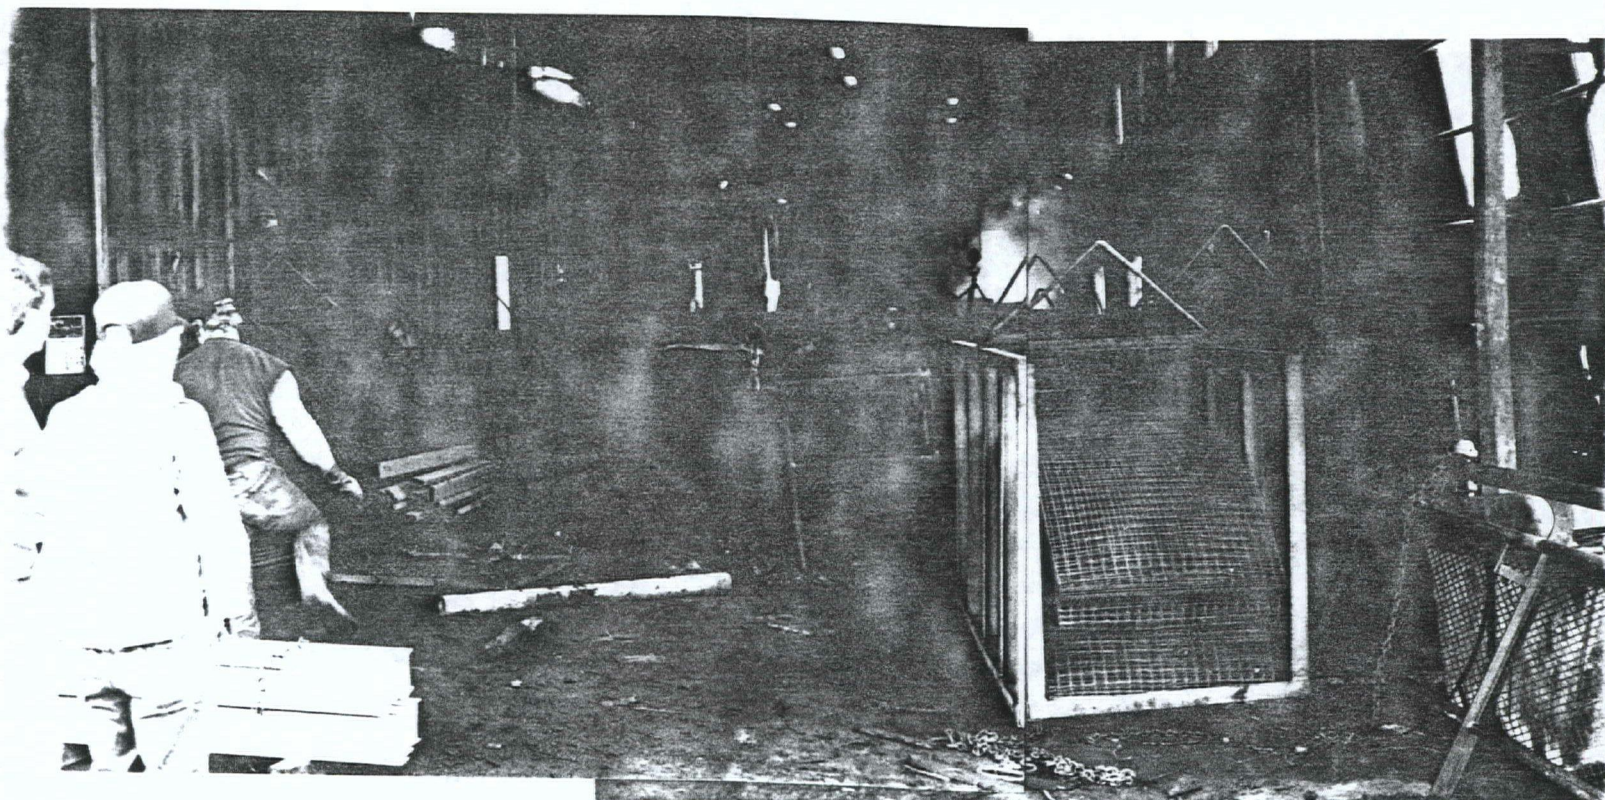
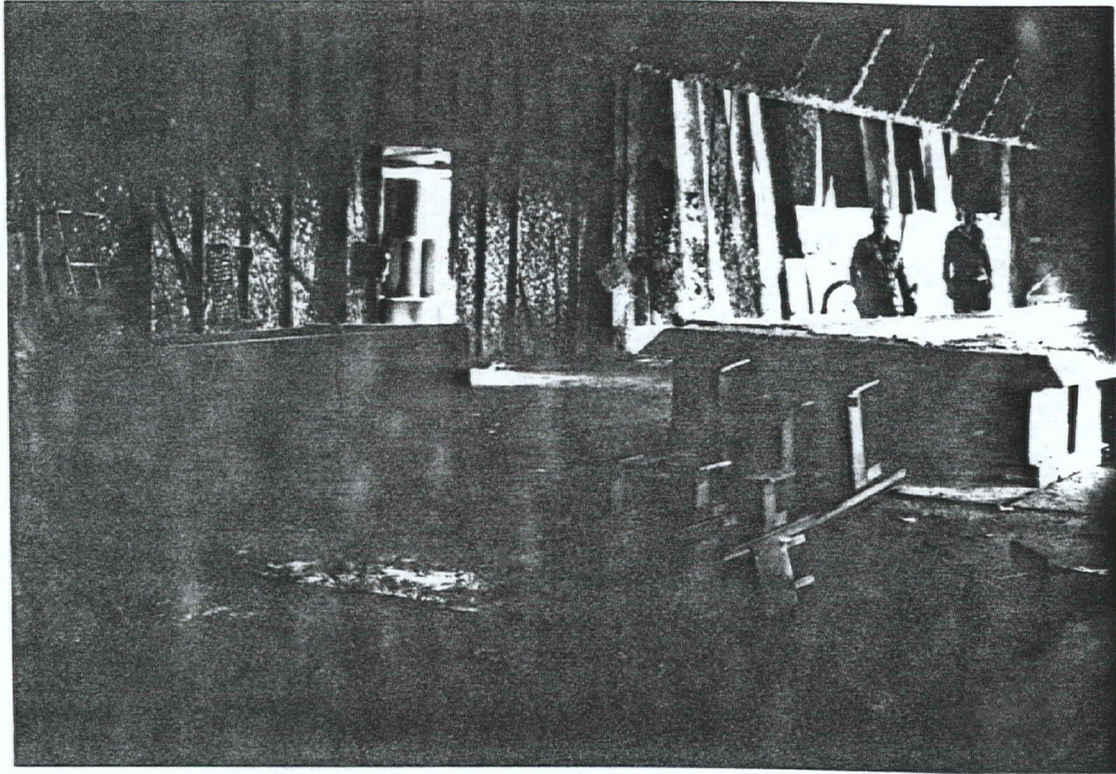
BEFORE PHOTOS

3. UNAUTHORIZED DISCHARGE TO STORM DRAINAGE, SOUTH-END OF GALVANIZING BUILDING.

Storm drainage at southern-end of galvanizing building-secondary containment within the galvanizing building and concrete berms and drainage ditches.

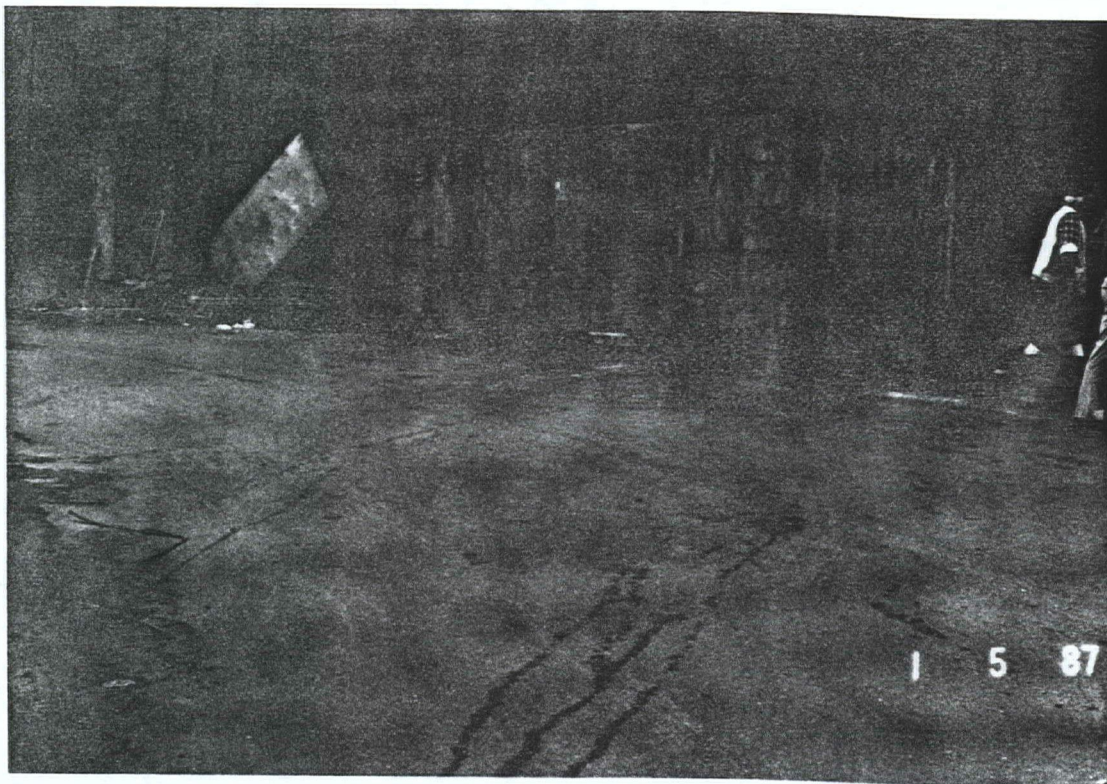
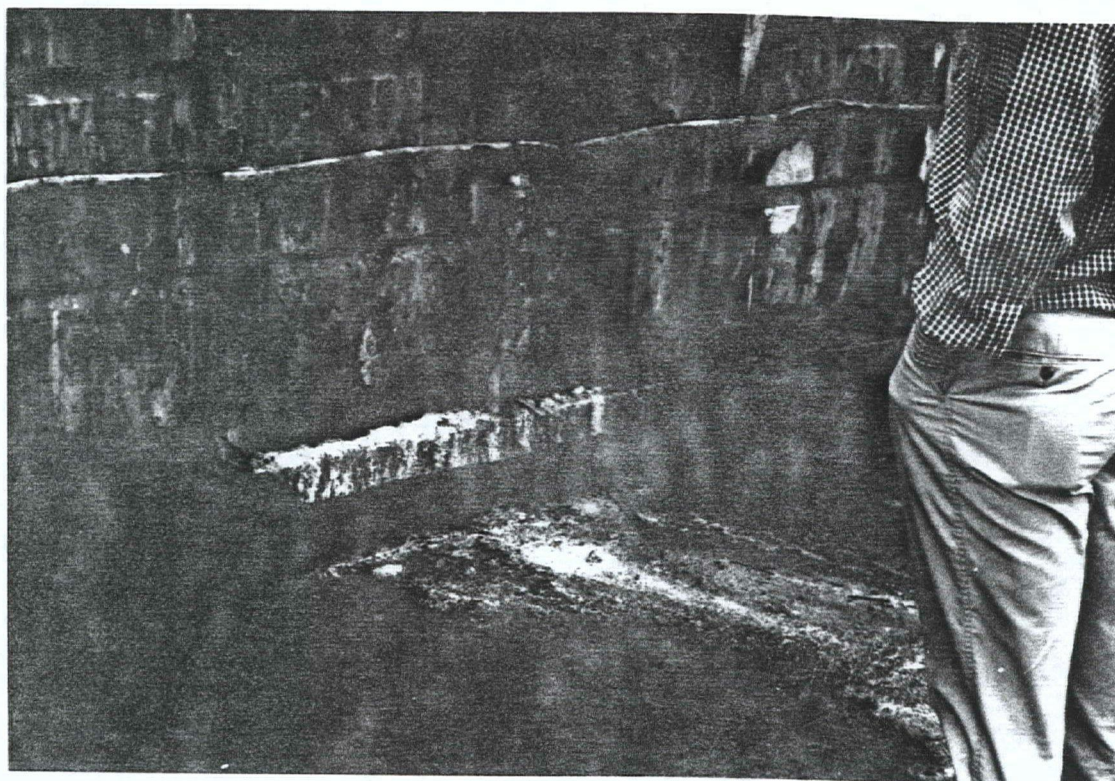
BEFORE PHOTOS

4. CONDITION OF DUMPSTER.

Condition and location of dumpster

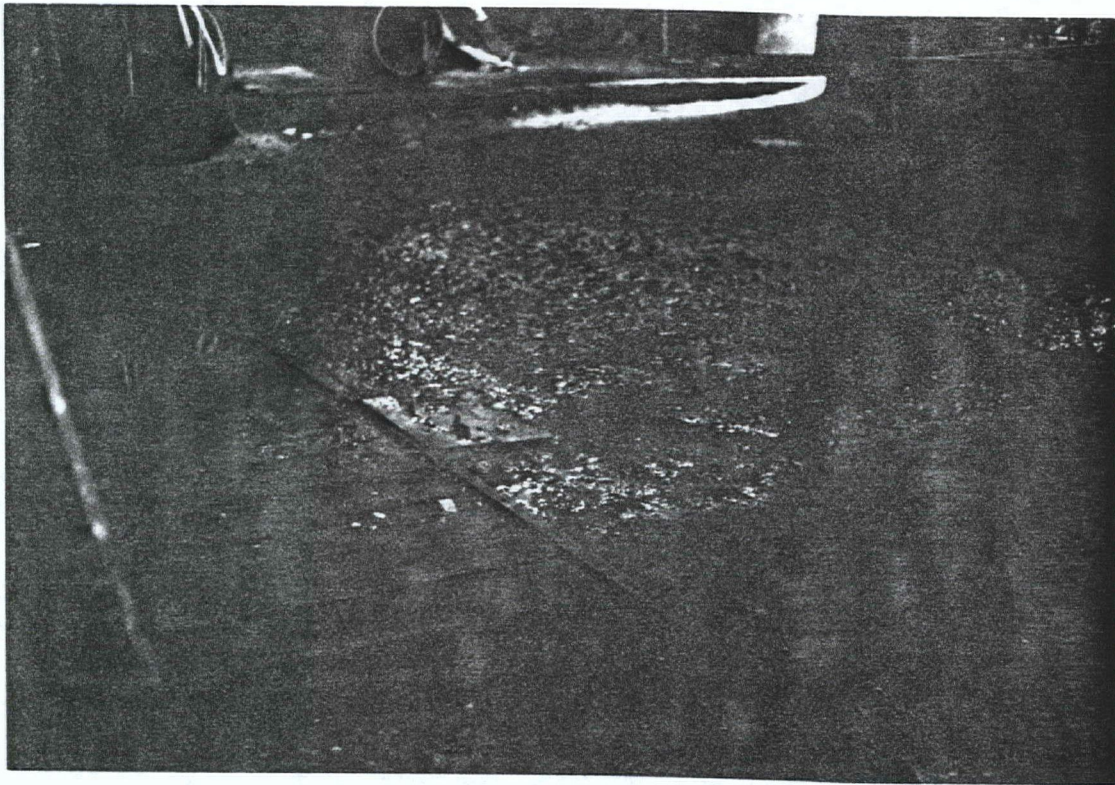
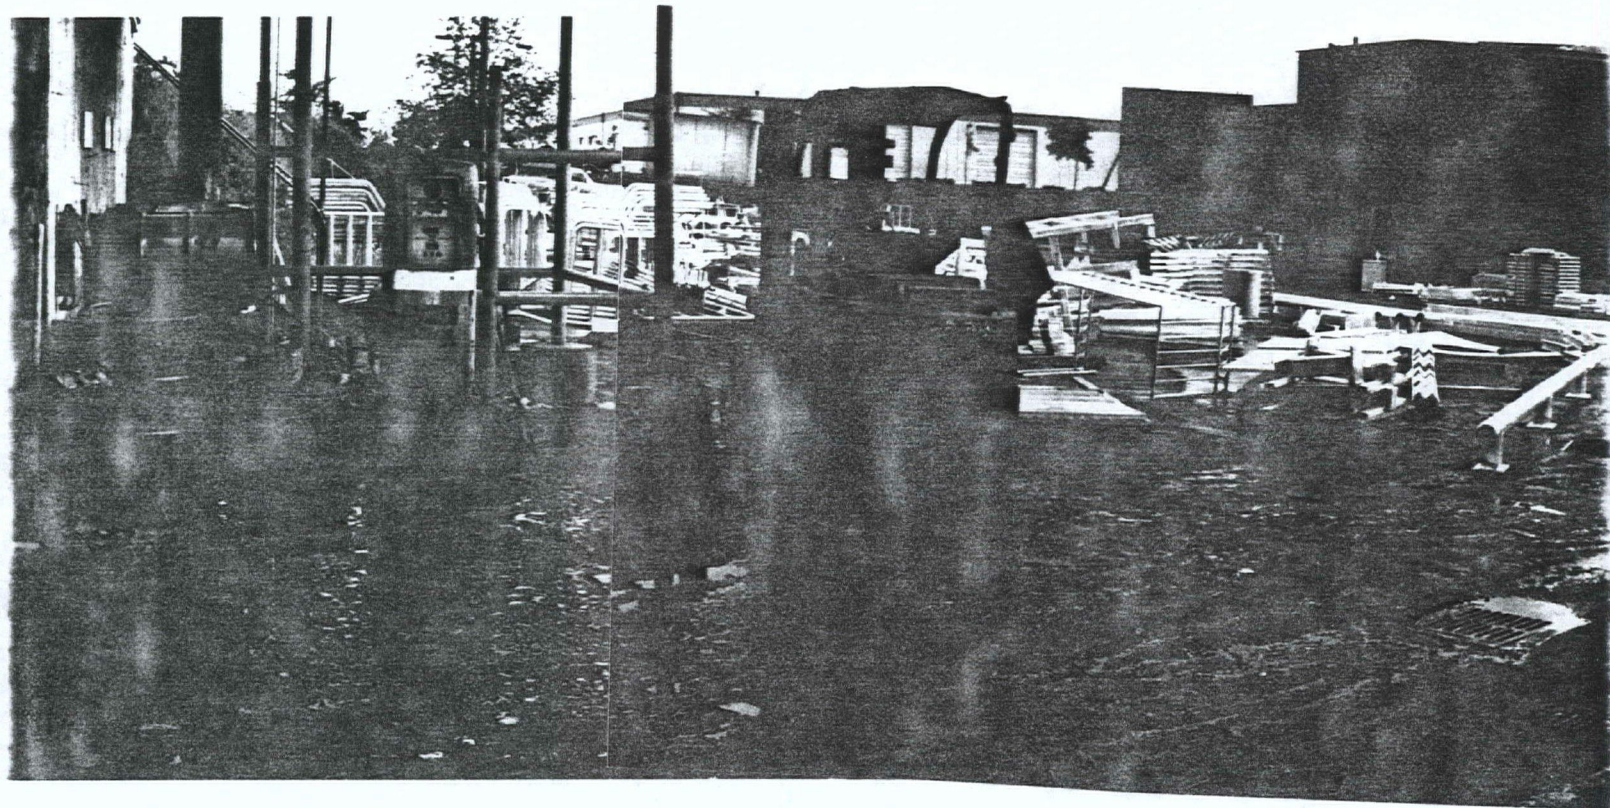
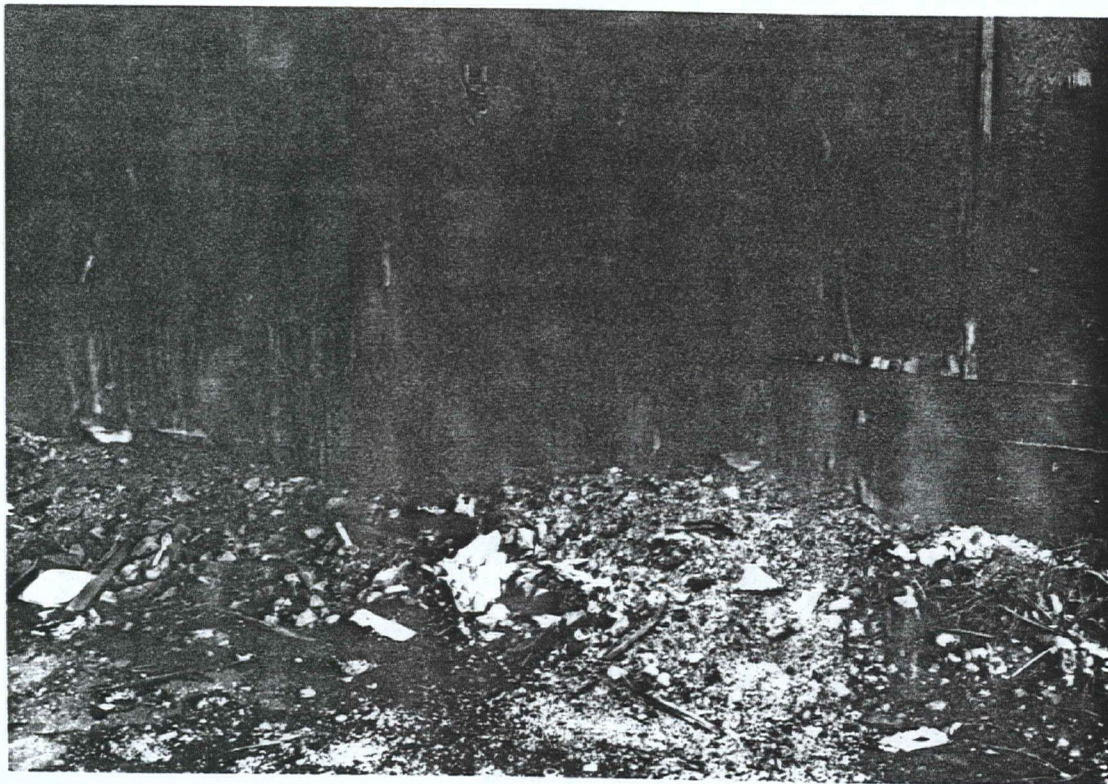
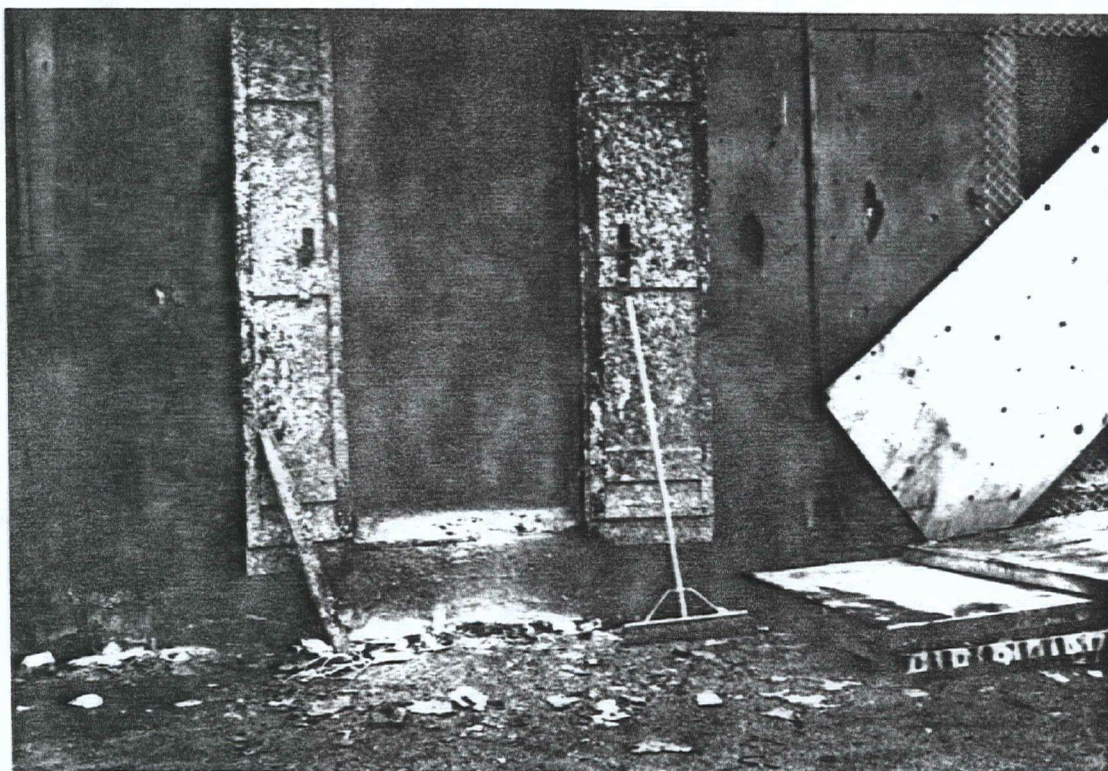
BEFORE PHOTOS

5. HOUSEKEEPING.

Containment and Housekeeping
